Dynamics of landslides and their impact on the Lake Kivu coastline for the period 2018 to 2020 (Nyabibwe, Kalehe Territory, South Kivu, DRC)

Abstract

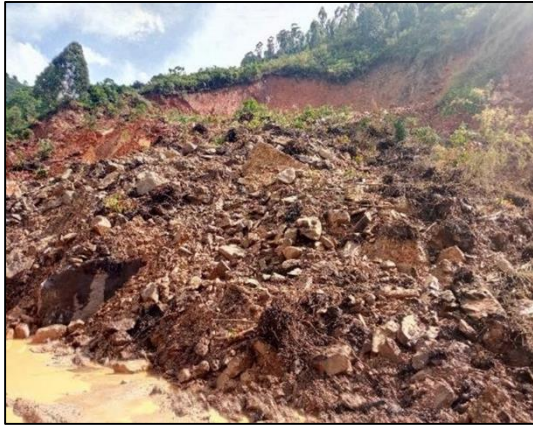
Fig 1: Landslides feeding debris into the river

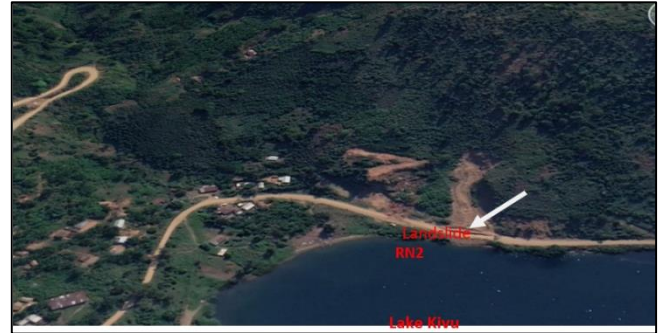
Fig 2: Sites of the measurements in Nyabibwe at the French - source Google Earth

the shores of Lake Kivu (Figure 2), but on the hills and slopes of certain plateaus, the soils are thinner because they are generally degraded by erosion. In the highlands, where erosive action is less intense, the soils are fertile and are more suitable for agro-pastoral use as a whole. The conquest of new arable land and the supply of woody resources are pushing the population of the region to destroy more and more of the forest, of which only a few relics remain (Mudinga *et al.* 2013) ^[11].

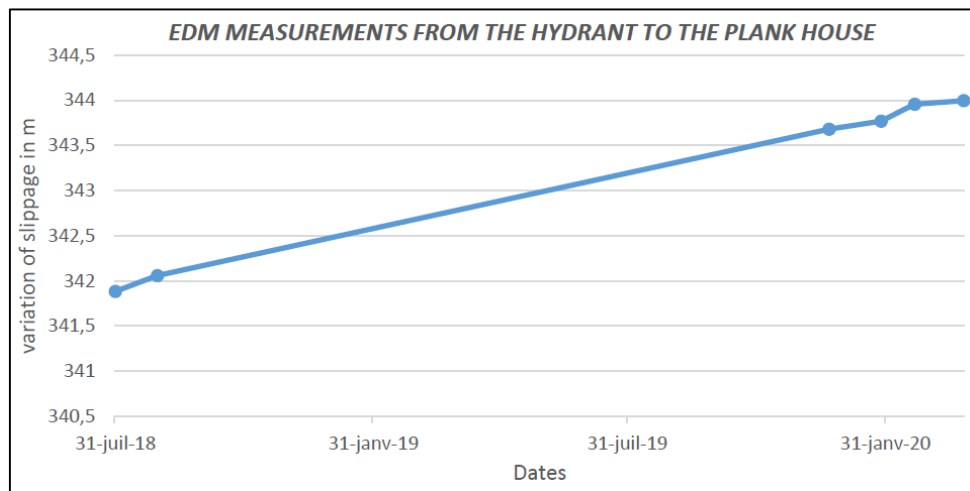
Fig 1

The change in gauges went from 341.8837085m on July 31, 2018 to 343.994963m on March 27, 2020, that is a change of 2.11m in one year and 9 months

Date	Distances	Variations in meters	Variations
Tuesday, July 31, 2018	341,8837085	Initial measurement	0
Thursday, August 30, 2018	342,0587524	0,1750439	0,175m
Friday, December 22, 2019	343,678932	1,7952235	1.795m
Thursday, January 28, 2020	343,768956	1,8852475	1.885m
Friday, February 21, 2020	343,956421	2,0727125	2,072m
Friday, March 27, 2020	343,994963	2,1112545	2,111m

The study of EDM measurements from July 31, 2018, to March 27, 2020, shows a total distance change of 2.11 meters. The increasing variation highlights ongoing geotechnical issues, particularly around Lake Kivu's fractures. Notable landslides, such as those at Bamba Nyamasasa and Makengele, have resulted in significant road subsidence and interruptions, emphasizing the critical need for timely intervention. The repeated disruptions, including the subsidence of roads and damage to infrastructure, underscore the urgency for continuous monitoring and preventive measures to mitigate further impact on road traffic and infrastructure stability.

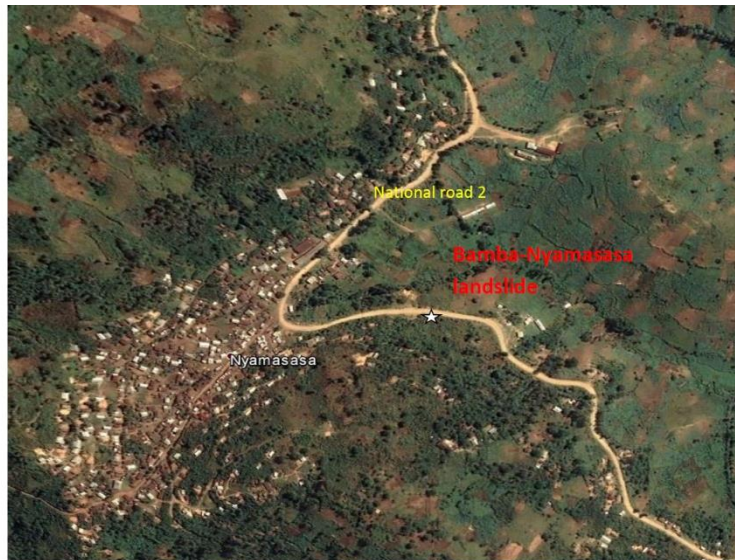
Fig 4: Bamba Nyamasasa landslide on the N2 road -source Google Earth

The landslide that threatened to cut off the Goma-Bukavu road at Bamba in Nyamasasa at coordinates 01.78714°South, 029.00676°East at an altitude of 1529m is evolving in the sense that the road at this site has already subsided by 30cm

and the nozzles are already broken. If measures are not taken in time, the road traffic will also be interrupted for a while at this location (cfr fig. 2).

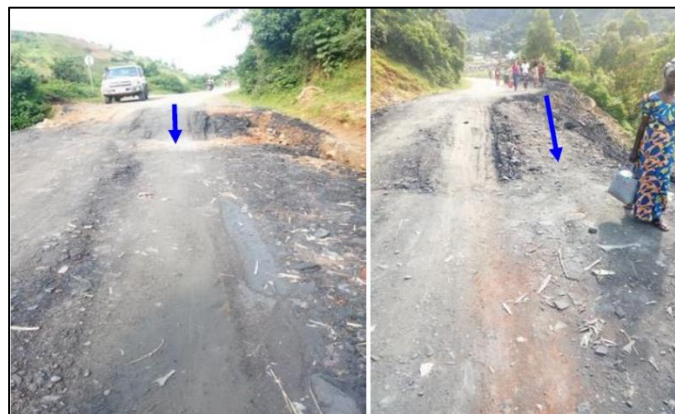
Fig 5: Subsidence and sliding of the road at Bamba-Nyamasasa

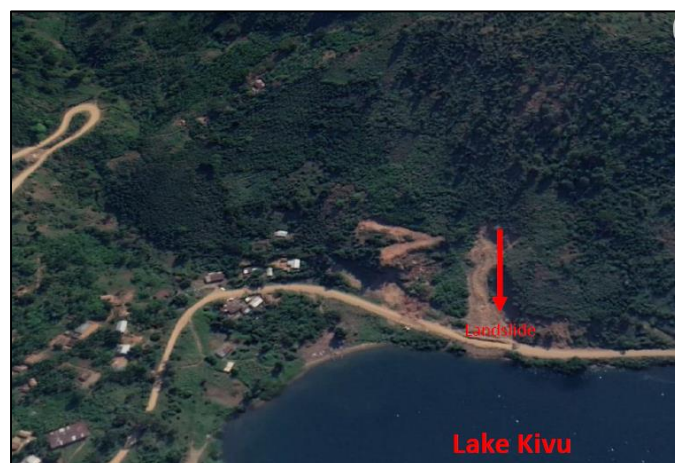
Fig 6: Landslide at Makengele Chez les Français -source Google Earth

On Thursday, April 30, another landslide occurred at Makengele at the bridges at $1^{\circ} 54' 33.17''$ S and $28^{\circ} 58' 38.07''$ E and traffic on the road was interrupted for ten days. During the night of May 14 to 15, the earth slipped again at the same place cutting again the road and the traffic interrupted (Cfr fig. N°3et 4).

Recall that a landslide occurred at this site in 2018 and interrupted traffic on this stretch for about ten days.

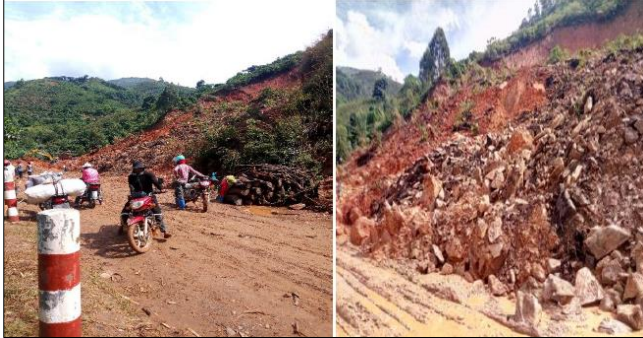
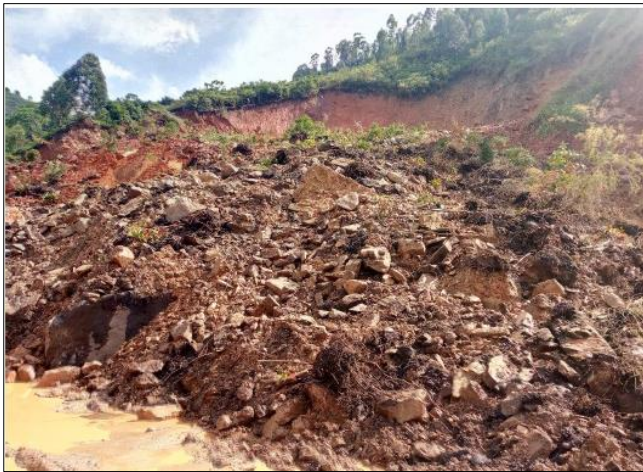
Fig 7: Landslide at makengele on the Goma-Bukavu road

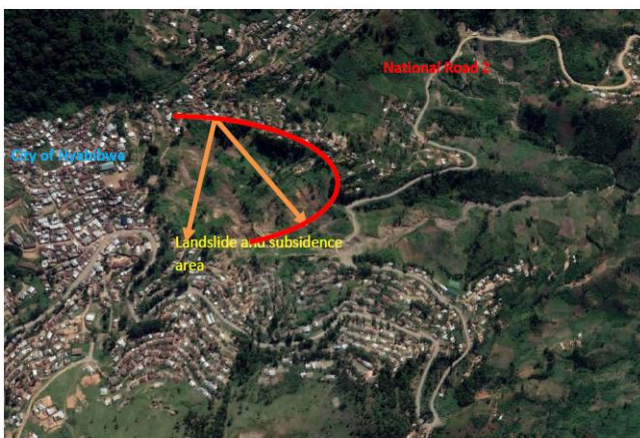
Fig 8: Landslide area at Nyabibwe Chez les Français -source Google Earth

Routine measurements were carried out in the landslide area in Nyabibwe where subsidence continues on the National Road N°2 at the level of the French.

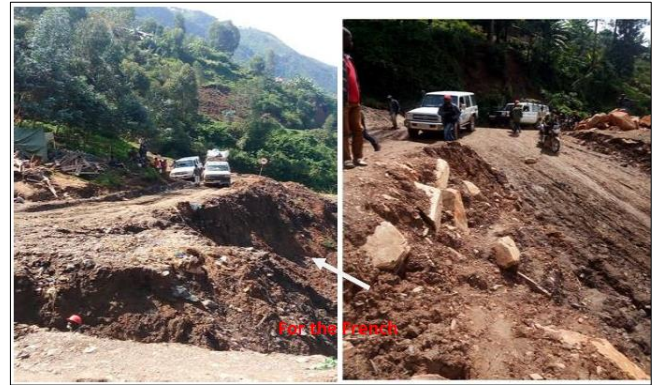
Fig 9: Subsidence zone at Nyabibwe Chez les Français
