Influence of welding speed on corrosion susceptibility of 304L stainless steel in chloride environment

Kutelu BJ^{1*}, Oke OO², Oyetunji A³

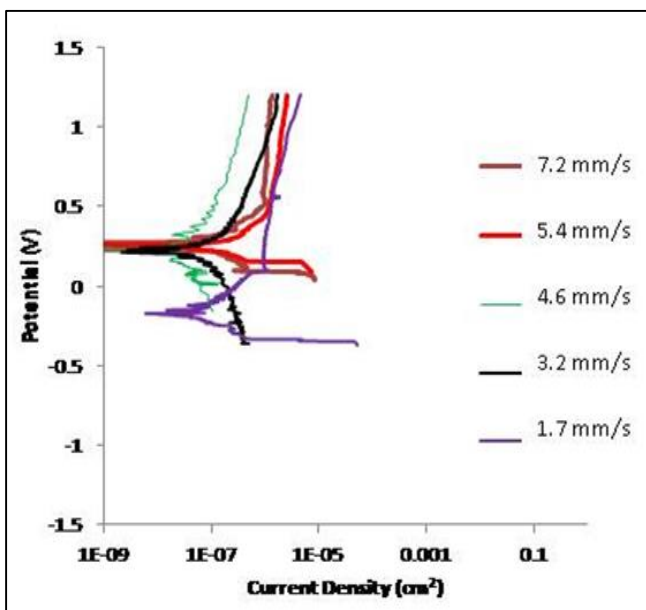
Fig 3: Potentiodynamic polarisation curves of the weldment at varied GTAW speed in demineralised water at 25°C

The potentiodynamic polarisation curves and corrosion rate of the weldment at varied GTAW speed are depicted in Figs. 3 and 4 respectively. Optimum E_{corr} values of $3.2253 \times 10^{-1} \text{V Ag/AgCl}$, was obtained at GTAW speed of 5.4 mm/s and least of $1.7327 \times 10^{-1} \text{V Ag/AgCl}$ at 1.7 mm/s. E_{corr} , i_{corr} and β_a values shifted to less negative directions (more nobility) and a more negative direction (less nobility) with increasing and decreasing GTAW speed respectively (Huabing *et al.*, 2015). And it is obvious from the characteristic features of the polarisation curves, the weldment is a passive alloy (Fotana, 2005) [13]. Chromium contribution to elemental composition of the experimental sample boiler pipe is 18.325wt. % (refer to Table 1). Chromium reacted with dissolved oxygen in the operating environment of the plant (demineralised water), forming thin oxide film (1-3nm thick),

The shift in corrosion potentials (E_{corr}) toward less negative direction (more nobility) at the GTAW speed ranges (5.4-7.2 mm/s) was due to fast cooling conditions with attendant high dislocation density, during which more diffusion paths were provided for migration of chromium to the surface, where double layer corrosion products of Fe_2O_3 and Cr_2O_3 were formed (Atapour *et al.*, 2015) [6]. And owing to the resulting relative fine-grained microstructures, the formed surface oxides assumed a compact, impervious and homogeneous

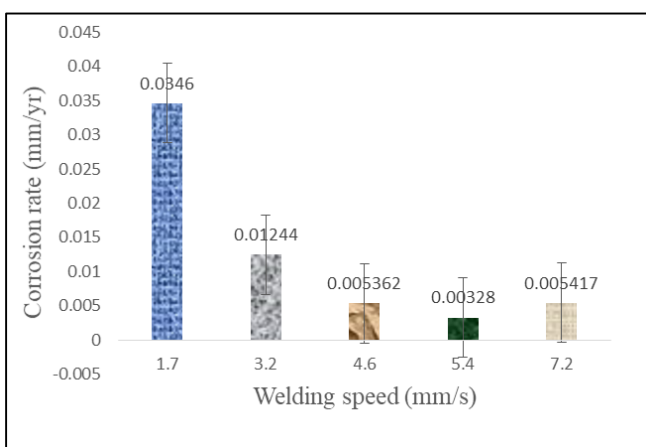
Fig 4: Influence of GTAW speed on corrosion rate of the weldment at 25°C
