International Journal of Multidisciplinary Research and Growth Evaluation.

Reliability Analysis of the PR012 Distribution Substation of PT. PLN ULP Praya Through Temperature Measurements

Muhammad Rivaldi Harjjan ¹, Akbar Tawaqqal ^{2*}

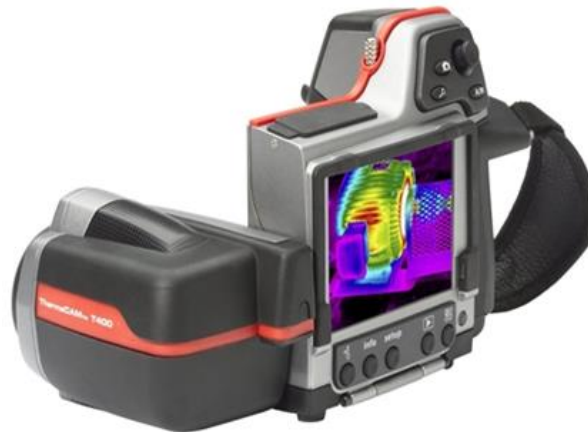
Fig 1: FLIR T4000 Camera

Like a thermometer, this device can measure an object's temperature without having to touch it. This is possible because the device receives or captures infrared radiation

from the object being measured, which is then processed into an image along with a temperature measurement. For specifications of the FLIR T400 thermal camera, see Table 2.

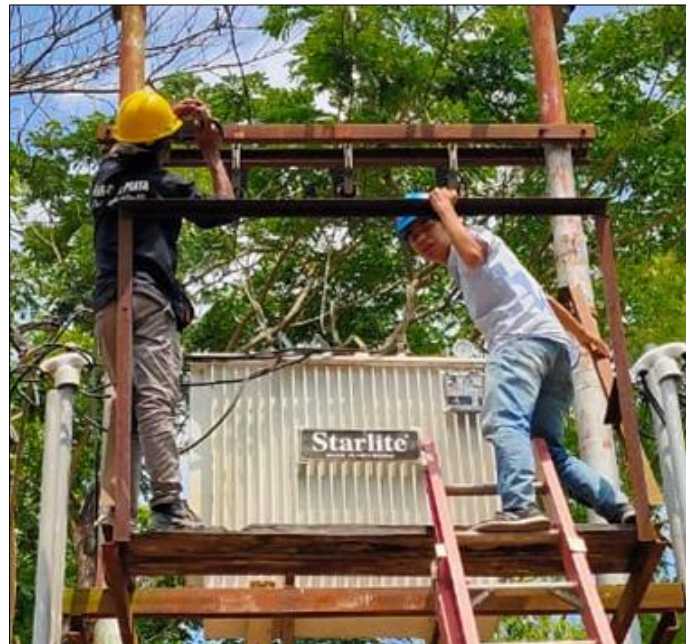
Fig 2: Transformer Body Thermal

In the distribution transformer body measurements carried out during the day at 13.47 WITA, the measurement results obtained can be seen in Figures 2 and 3.

Fig 3: Visualization of the Transformer Body

Based on the thermal measurement results above in Figure 5.2.(a) with a Temperature scale between 5.9°C-56.6°C, the temperature measurement on the transformer body was 50.5°C. It can be seen from the color of the measured transformer body which is orange. This is because the distribution transformer body contains coils and an iron core where these components function as a voltage and current transformation tool. Because of this, heat is generated on the

transformer body.

Based on Table 3. The measurement results show that the highest temperature is found in the transformer body at 50.5°C, followed by the top packing of the transformer at 49.3°C, the TR fuse in the C direction at 49.1°C, the TM bushing at 47.9°C, the TR bushing at 47.4°C, the cable at 46.6°C, and the TR rack handle at 44°C. Based on the temperature distribution, it can be seen that all components experience an increase in temperature due to the flow of electric current and power losses that occur during transformer operation.

The increase in temperature in the transformer body is primarily influenced by core losses and copper losses. Core losses originate from hysteresis and eddy currents in the iron core, while copper losses are caused by the current flow in the transformer coils. The higher the transformer load, the greater the current flowing, resulting in an increase in temperature. This condition is in accordance with the theory that the amount of heat generated is proportional to the square of the current based on the power loss equation:

Compared with the thermal measurements obtained, all components in the PR 012 transformer remained below the critical temperature limit. The maximum measured temperature of 50.5°C on the transformer body was still within the safe range. This indicates that the transformer's cooling system is still functioning properly and there are no indications of overheating, which could accelerate insulation degradation.

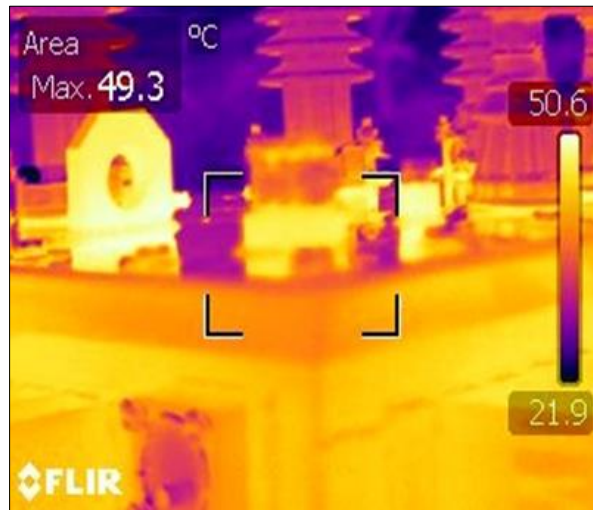
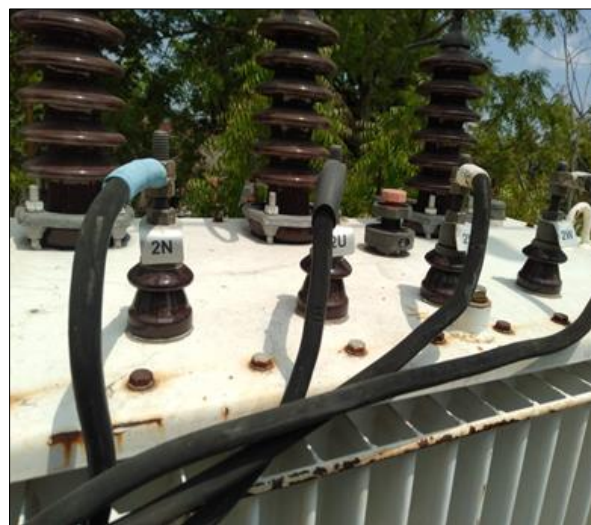
Fig 4: Transformer Top Packing Thermal

In the measurement of the distribution transformer's top packing which was carried out during the day at 14.10 WITA, the thermal measurement results were obtained which can be seen in Figure 4 and visually in Figure 5.

Fig 5: Visual of the Top Transformer Packing

Based on the thermal measurement results of the transformer's top packing in Figure 5.3.a with a temperature scale of 21.9°C-50.6°C, the temperature measurement on the top packing of the transformer was 49.3°C, which is seen in orange. This is because there is a current flowing in the transformer, namely in the coil, which causes heat in the transformer packing.

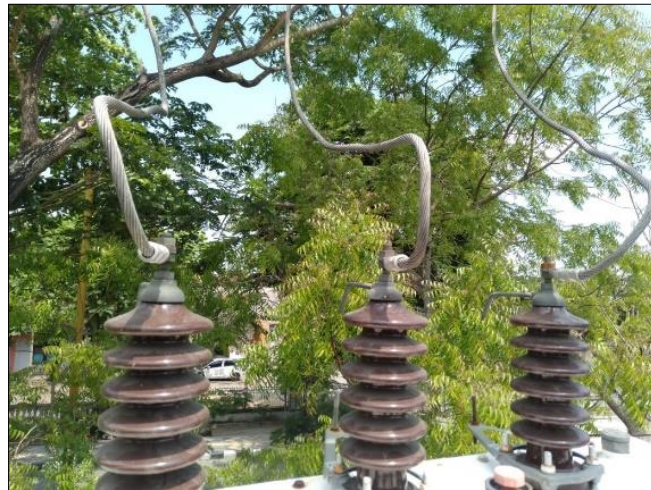
Fig 6: Thermal Bushing TM Transformer

In the measurement of the TM bushing of the distribution transformer which was carried out during the day at 14.15 WITA, the thermal measurement results were obtained which can be seen in Figure 6 and visually in Figure 7.

Fig 7: Visual Bushing TM Transformer

Based on the results of thermal measurements on the medium voltage transformer bushing in Figure 5.4.a with a temperature scale of 28°C-50.8°C, the temperature measurement value of the medium voltage bushing was 47.9°C. This is because the bushing is a conductor coated with an insulator which then receives a 20-kV voltage supply from the JTM so that a current flow in the bushing. This continuous current flow which causes heat to arise in the

bushing.

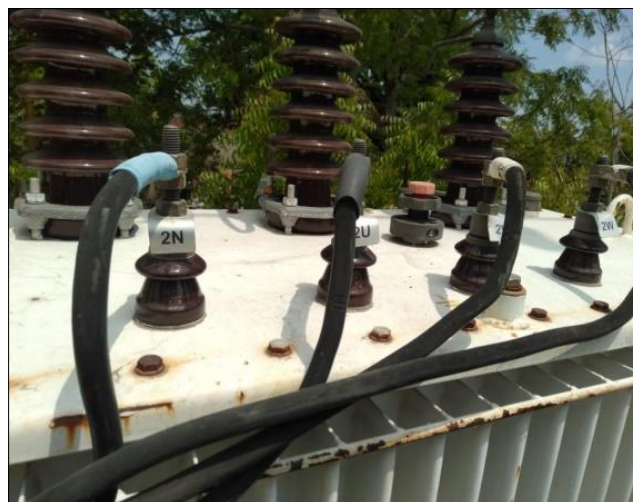
Fig 8: Thermal Bushing TR Transformer

In the measurement of the TR bushing of the distribution transformer which was carried out during the day at 14.13 WITA, the thermal measurement results were obtained which can be seen in Figure 8 and visually in Figure 9.

Fig 9: Visual Bushing TR Transformer

Based on the results of thermal measurements on the low-voltage bushing of the transformer with a temperature scale of 17.6°C-53.7°C, the temperature measurement value on the low-voltage bushing was 47.4°C. This is caused by the transformer supplying a voltage that has been stepped down from 20 kV to 220 v, so that in the bushing on the low-voltage side there is a current flowing which then causes heat in the

bushing.

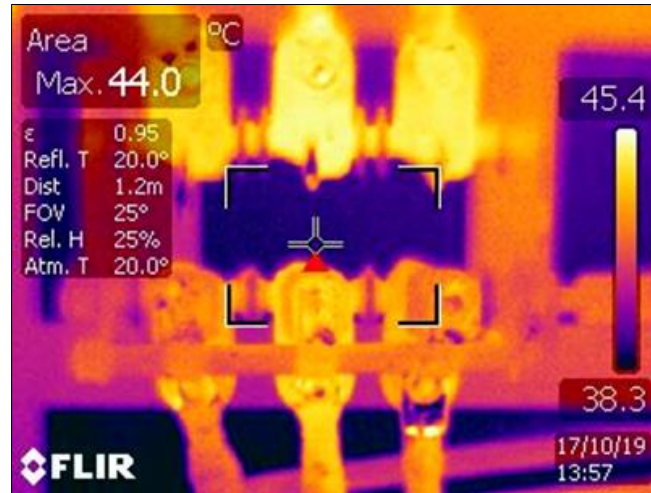
Fig 10: Thermal Handle of TR Trafo Rack

In the measurement of the distribution TR rack handle which was carried out during the day at 13.57 WITA, the thermal measurement results were obtained which can be seen in Figure 10 and visually in Figure 11.

Fig 11: Visual Handle of the TR Trafo Rack

Based on the results of thermal measurements on the TR rack handle with a temperature scale between 45.5°C-38.3°C, the temperature measurement value on the low voltage rack handle is 44°C. This is because there is a current flowing in the TR rack handle. However, there is a difference in color on the incoming and outgoing sides where there is a difference in temperature color, this is because the switch on the TR rack handle is turned off. It can be seen that the incoming side is brighter in color with a temperature of around 44°C than the color on the outgoing side with a

temperature of around 41°C because the current is stopped on the incoming side and there is no current flowing on the outgoing side.

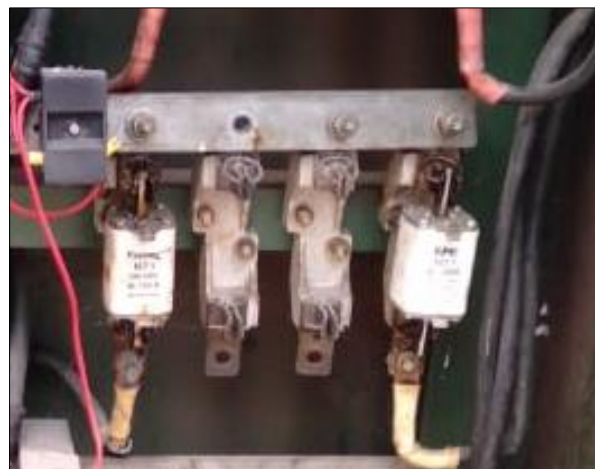
Fig 12: Thermal Fuse TR Transformer

In the distribution TR fuse measurement carried out during the day at 13.57 WITA, the thermal measurement results were obtained which can be seen in Figure 12 and visually in Figure 13.

Fig 13: Visual Fuse TR

Based on the results of thermal measurements on the TR Fuse, it can be seen that the PR036 substation uses 2 routes, where the two Fuse routes have different temperatures. On Fuse Route C, the thermal measurement is bright yellow, which indicates that the Fuse C temperature is very hot and the measured temperature is 49.1°C. While on route A, the thermal measurement is orange with a temperature ranging from 43-44°C and tends to be the same as the color of the route next to it where there is no Fuse. This is because there is a current flowing which causes heat to arise in the Fuse,

and this also indicates that there is an imbalance in the load in both routes so that the current flowing is not the same which causes a difference in the measured temperature on the Fuse.

However, the measurement results on the TR fuse show a temperature difference between the A and C lines.

The C line fuse has a temperature of 49.1°C while the A line fuse is in the range of 43–44°C. This temperature difference indicates an imbalance in the load between phases or between feeders. Load imbalance can cause uneven current distribution so that one line experiences a higher load than the other.

1. Increased power losses in transformers;
2. Accelerated aging of insulation;
3. Decrease in efficiency of distribution system;
4. Reduced operating life of transformer.

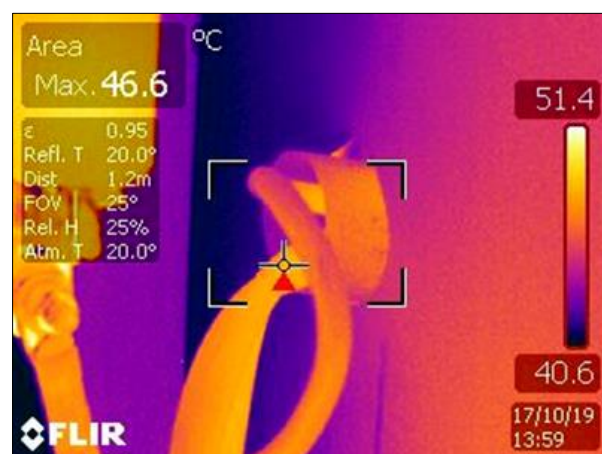
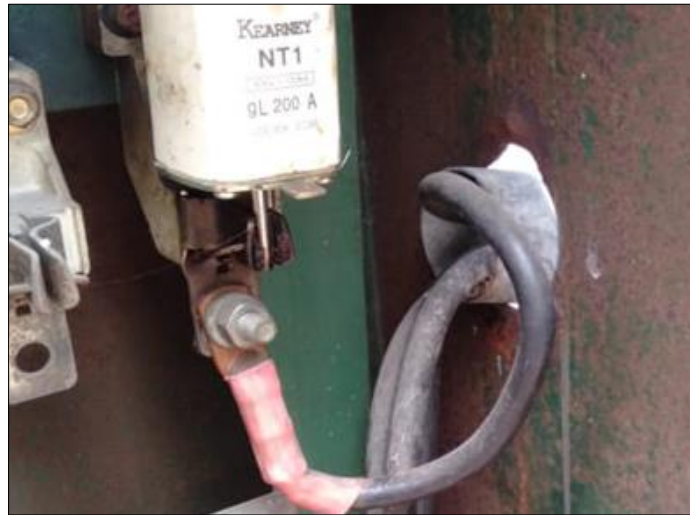
Fig 14: Thermal Fuse Cable

In the measurement of the outlet cable carried out during the day at 13.59 WITA, the thermal measurement results were obtained which can be seen in Figure 14 and visually in Figure 15.

Fig 15: Fuse Cable Visualization

Based on the thermal measurements of the cable above, the cable's thermal color is orange with a measured temperature of around 46.6°C. This is due to the current flowing through the cable. Continuous current flow causes the cable's temperature to rise. The cable used is NYY, a cable with a PVC-insulated copper core, with a single or multiple core, and a PVC outer sheath.
