Utilization of sediment pin to describe the beach accretion by riverine mangroves

Randy A Quitain

College of Arts and Sciences, Mindoro State University, Oriental Mindoro, Philippines

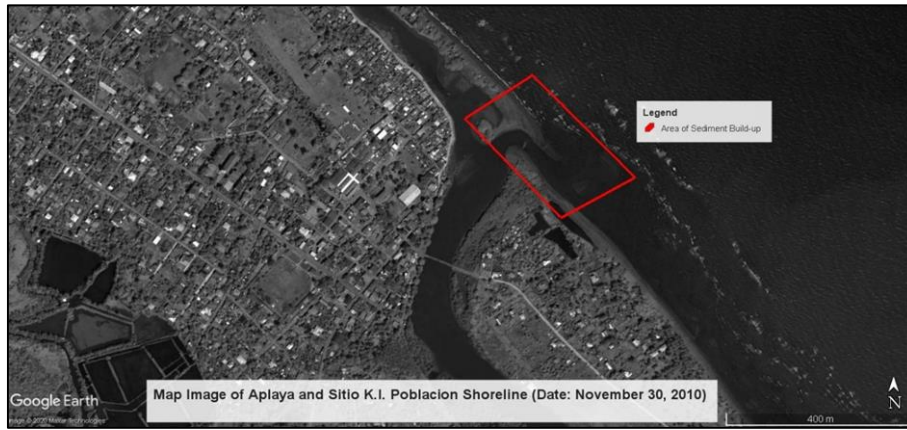
Fig 3: The Baseline Map of Sediment Deposit Occurrence along the Beach of Barangay Aplaya and sitio K.I. Poblacion Shoreline dated November 30, 2010

In terms of sediment deposition, Figure 3, the baseline map of sediment deposit occurrence along the beach of Barangay Aplaya and sitio K.I. Poblacion shoreline dated November

30, 2010, delineated by a red quadrant, reveals no sediment accumulation in the estuarine along the beach of Barangay Aplaya and sitio K.I., Poblacion.

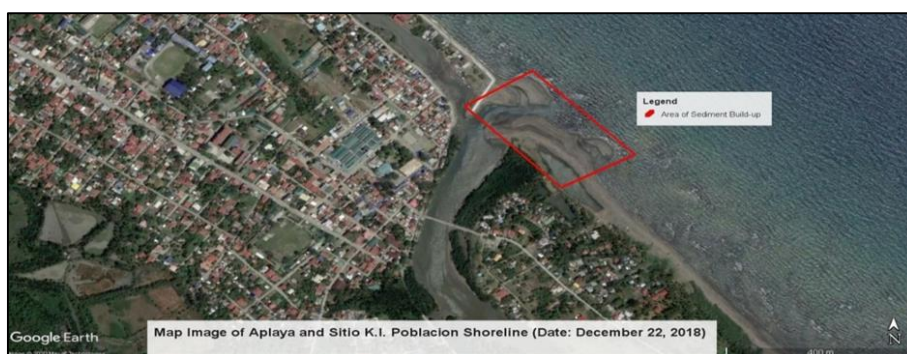
Fig 5: Map image of Barangay Aplaya and sitio K.I. Poblacion Beach dated December 22, 2018

The massive accumulation of sediment is shown in Figure 5, Map image of Barangay Aplaya and sitio K.I. Poblacion

beach dated December 22, 2018.

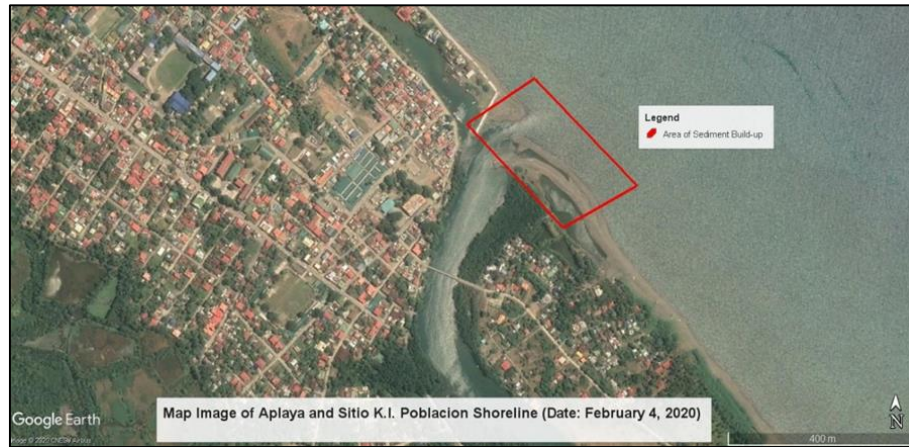
Figure 6. Map image of Barangay Aplaya and sitio K.I., Poblacion beach dated February 4, 2020

The stable condition of the beach along Aplaya and sitio K.I. Poblacion is shown in Figure 6, Map image of Barangay Aplaya and sitio K.I. Poblacion beach dated February 4, 2020, due to the regulated distribution of sediment materials trapped in the mangroves of Sukol River. They made the substrate materials firm as tides shift and flood passes through the channel.
