# International Journal of Multidisciplinary Research and Growth Evaluation.

## Major natural hazards in Nepal Himalaya

Ramji Kshetri

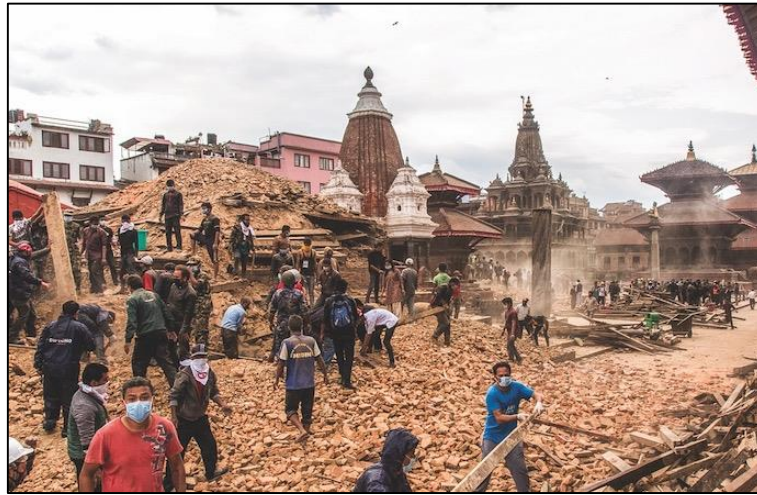
**Fig 2:** Damaged sacred site in Kathmandu valley after 2015 Earthquake

This devastating earthquake resulted in thousands of people being left homeless, with entire villages flattened across many districts. The earthquake also caused significant destruction to centuries-old buildings at World Heritage Sites in the Kathmandu Valley, including Kathmandu Durbar Square, Patan Durbar Square shown in Figure 2, Bhaktapur Durbar Square, Changu Narayan Temple, Boudhanath Stupa, and Swayambhunath Stupa. Subsequent aftershocks continued to affect Nepal, with a 6.7 magnitude aftershock on April 26, 2015, and a major 7.3 magnitude aftershock on May 12, 2015. The consequences of these earthquakes resulted in 8,970 fatalities, with 198 people missing and 22,303 seriously injured. A total of 604,930 houses were destroyed completely, and 288,856 houses were partially damaged. The estimated total value of the damages caused by the earthquakes is NPR 706 billion, or approximately US\$ 7 billion [7].

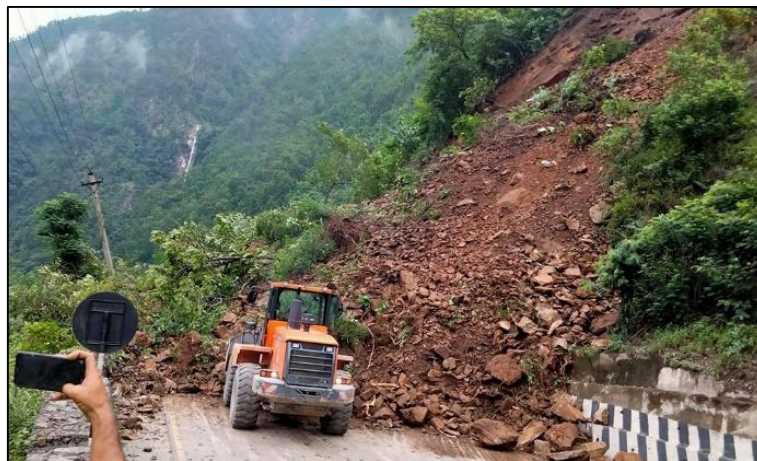
**Fig 3:** landslide obstructs the highway in Nepal

the hills particularly vulnerable to landslides. The steep gradients of Himalayan rivers and streams significantly contribute to various types of landslides. Each year, especially during the monsoon season, landslides cause considerable damage to life and property. Many hill villages in Nepal are situated on unstable slopes or old landslides, which are periodically reactivated.

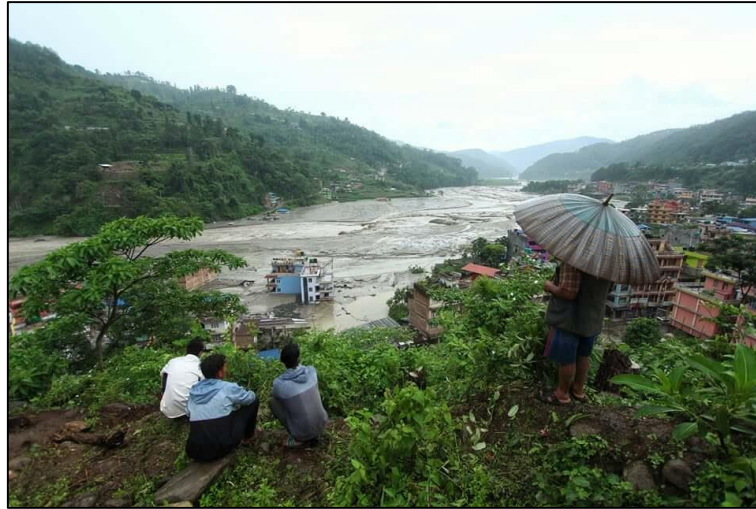
**Fig 4:** Deadliest flooding in Melamchi Bazar Sindhupalchowk in 2021

embankment breach floods, the 2013 and 2014 floods in the mid and far western regions, and the Melamchi floods of 2021 shown in Figure 4, all of which caused immense loss of life and property and had a devastating impact on development.

On June 15, 2021, a massive sediment-laden flash flood occurred in the Melamchi River, Nepal, resulting in significant losses and destruction to the settlements. A subsequent flood on July 31, 2021, caused further damage with large debris. The Melamchi events damaged 252 households in Helambu and 287 households in Melamchi municipality, cutting off road access to several settlements. The disaster resulted in 5 human casualties, left 20 people missing, and deposited debris over 10 meters high in Melamchi <sup>[12]</sup>. A flood hazard report following the disaster suggested that the flood was exacerbated by the outburst of the Pemdan glacial lake (located upstream in the Melamchi catchment), which destroyed the natural dam in the

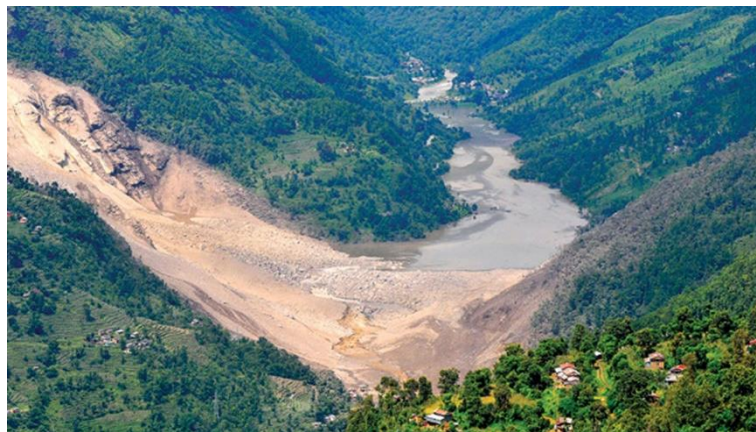
**Fig 6:** A massive landslide formed temporary dams in the Sunkoshi River in Sindhuplachowk in 2014

Massive landslides called Jure landslides formed the temporary dam in the Sunkoshi River in 2014 shown in Figure 6. The landslide, characterized by typical slope failure with massive rock fragments, sand, and soil, deposited a large volume of debris in the Sunkoshi River, blocking its waterway. It took nearly 12 hours for the lake to fill and overflow the debris dam, creating a potential threat of a lake outburst flood <sup>[18]</sup>. However, the lake was released by blasting method to reduce the potential risk of LDOF.

One of the most significant landslides in Nepal's history occurred in Jure village, Sindhupalchowk, on August 2, 2014, at around 2:36 am local time shown in Figure 6. According to local newspapers, this massive, rainfall-induced landslide killed 156 people [8]. The landslide, characterized as a rock avalanche or slope failure, deposited a large volume of debris in the Sunkoshi River, blocking it and creating a potential threat of a lake outburst flood. It took nearly 12 hours for the lake to fill and overflow the debris dam [8]. The dam was eventually released by blasting. A local earthquake of magnitude 3.3 was recorded that day due to the landslide, as reported by the Ministry of Irrigation, Nepal Government. Figure 3 exhibits the typical landslide that often happens in Nepal, especially in the monsoon season. Recently, on 12th July 2024, two-night buses were swept away into a swollen river by a massive landslide at Simaltal on the Narayangarh-

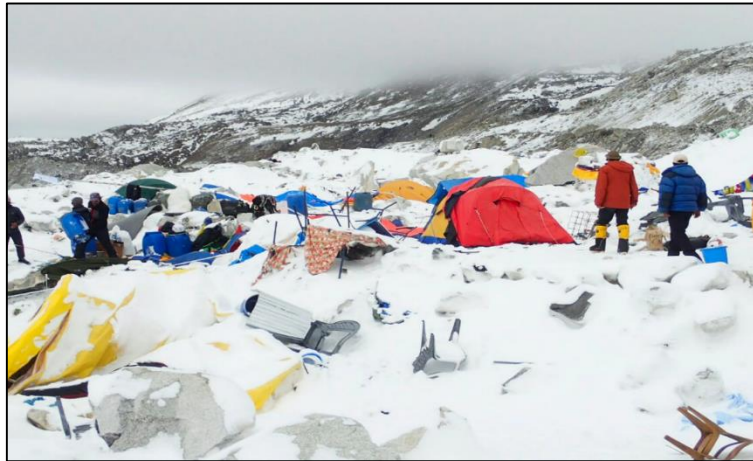
**Fig 7:** Massive snow avalanche plowed through Mount Everest base camp after earthquake in 2015

On April 25, 2015, a powerful earthquake measuring 7.8 magnitude triggered an avalanche from Pumori into the Everest Base Camp shown in Figure 7. This event resulted in

the deaths of at least 23 people and 61 injured [19], making it the deadliest disaster on Mount Everest at the time,
