## Risks related to the eruption of the Nyiragongo Volcano on 22 May 2021: Case of Fracturation in the Mabanga and Bujovu quarters. Goma /North Kivu Province/DR Congo

<sup>1-3, 5, 5, 7-9</sup> Department of Geodesy and Deformation, Goma Volcano Observatory, Goma, DR Congo

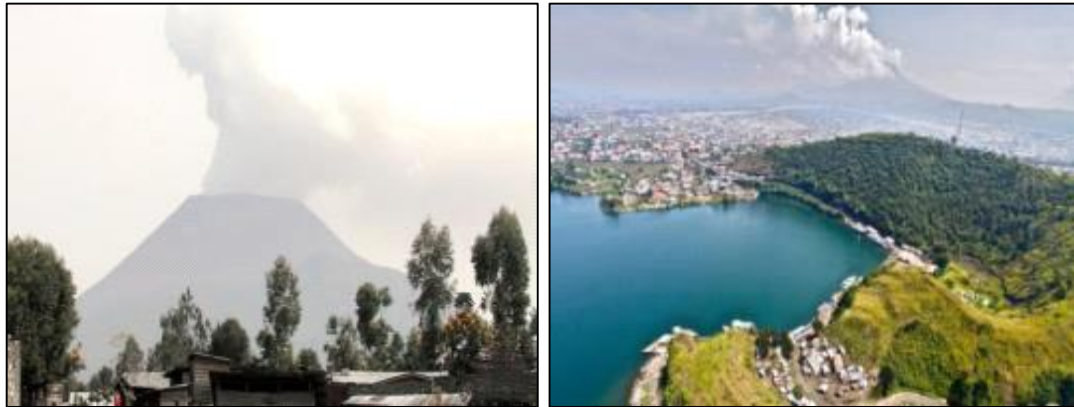
**Fig 2:** Figure of the Nyiragongo volcano and the city of Goma at its flank

Nyiragongo is a stratovolcano rising to 3470m above sea level, located about 18km north of the city of Goma and Lake Kivu in the Democratic Republic of Congo. Part of the Virunga volcanic chain, it is one of the volcanoes of the western branch of the Great East African Rift Valley and is located in the Virunga National Park. It is surrounded by the

Nyamulagira volcano to the northwest and by the Karisimbi and Mikeno volcanoes to the east, Lake Kivu, the city of Goma and Rwanda (Gisenyi part) on the southern flank at the foot of this volcano. It represents a great risk for the population of the city of Goma and its surroundings but also in the world.

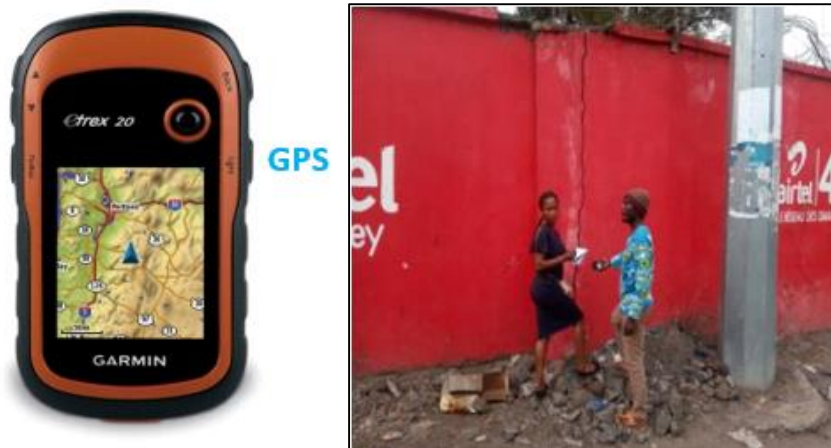
**Fig 3:** Raising with the help of a GPS

The data used in this study comes from GPS (Global Positioning System) coordinates, for the determination of the geographical coordinates of the places where we observed the fracturing in the two districts: Mabanga and Bujovu. The Garmin GPS with an accuracy of 3m. The points collected were taken at the location where the cracks or large fractures were observed. We went through the places and quarters to follow with our GPS the general trend of these openings including the NNW - SSE as well as their orientation. Bujovu and Mabanga attracted our attention because they were the areas that were most affected by the different earthquakes that were felt in the Virunga region during the volcanic eruption of 22 May 2021.

GPS is set up either in degrees or in UTM (Universal Transverse Mercator). After turning on the GPS, it must first pick up the satellites which will send signals directly. These signals are directly in a straight line with no obstructions on the side of the satellites and the GPS, hence a place where the sky is clear. Once the sky is clear, we wait until the accuracy is displayed (3m) and the GPS gives us our position, i.e. Latitude, Longitude and altitude of all the points we have to cover. Our observations during the descent on the ground at the time of the many seisms felt after the volcanic eruption of

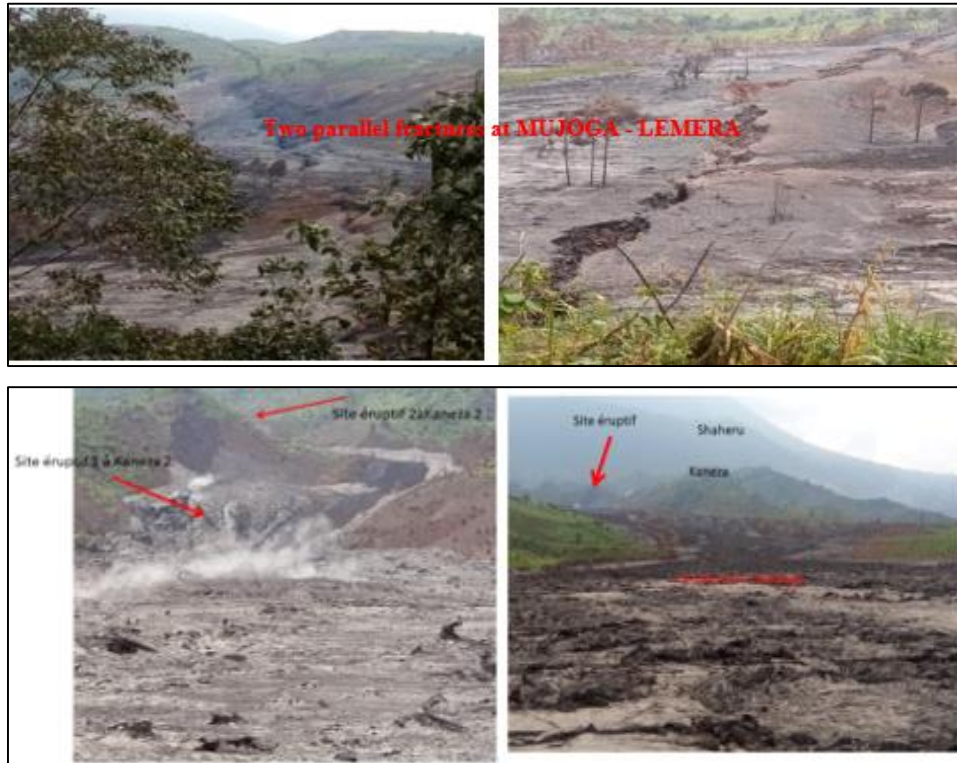
**Fig 4:** The different eruptive sites (Mugoga, Kaneza, Shaheru)

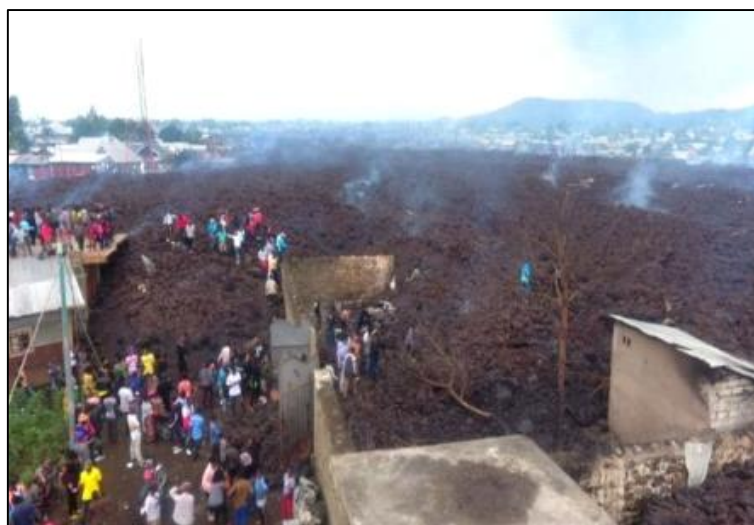
**Fig 5:** Destruction of houses by lava in May 2021

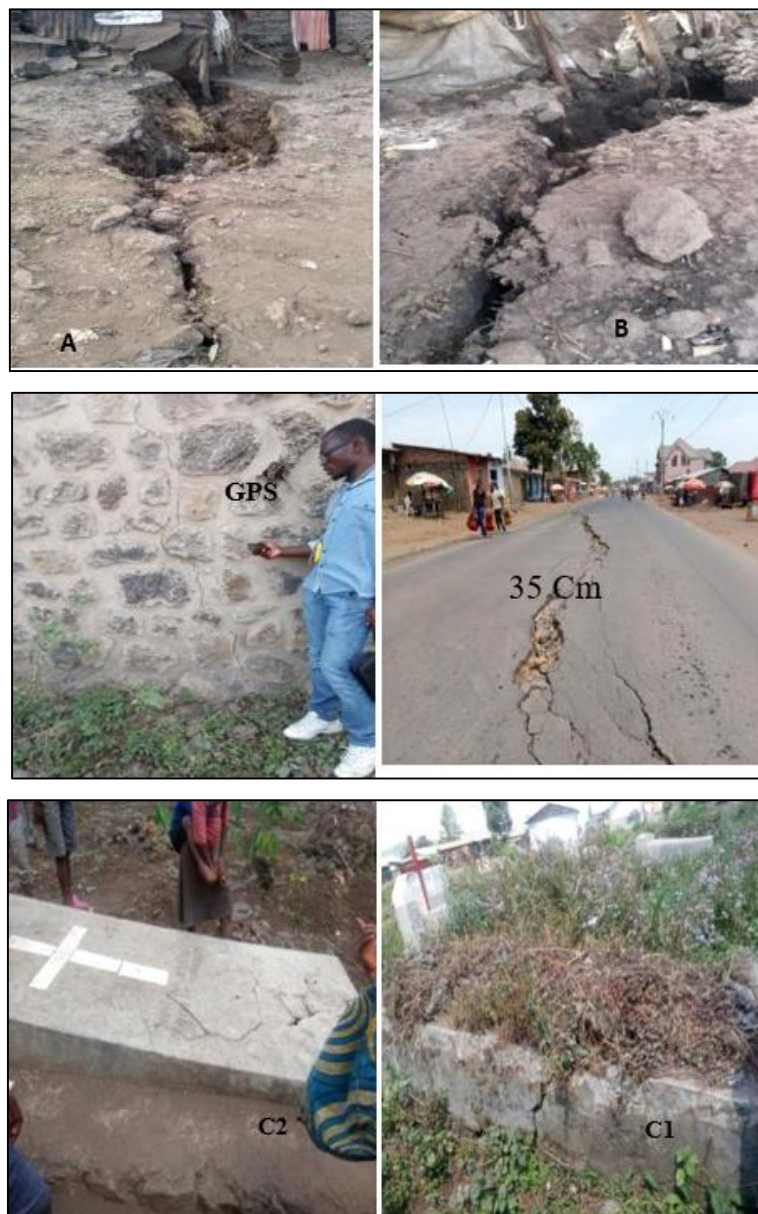
The preferred orientation of the fractures was NNW/SSE and WNW/ESE. The fracture from these vents towards Birere and Rwanda. This fracture from the top through the Mujonga cone passes into the Bujovu district to Rwanda. A 35 cm opening in the road leading to the airport at the time of the numerous earthquakes felt during the Nyiragongo volcanic eruption, which worried the staff working at the airport as well as the inhabitants living in the neighbourhood.

While surveying in this area, we observed that the houses; the road, the cement workers were much affected. In some places, the fractures in the house were 1m, with the lack of support and help the population proceeded to fill these fractures by stone to allow them to still live in their house forgetting any danger.

**Fig 6.** (a) Destruction of the wall, (b) airport road and (c<sub>1</sub> c<sub>2</sub>) the graves of the SEP CONGO cemetery

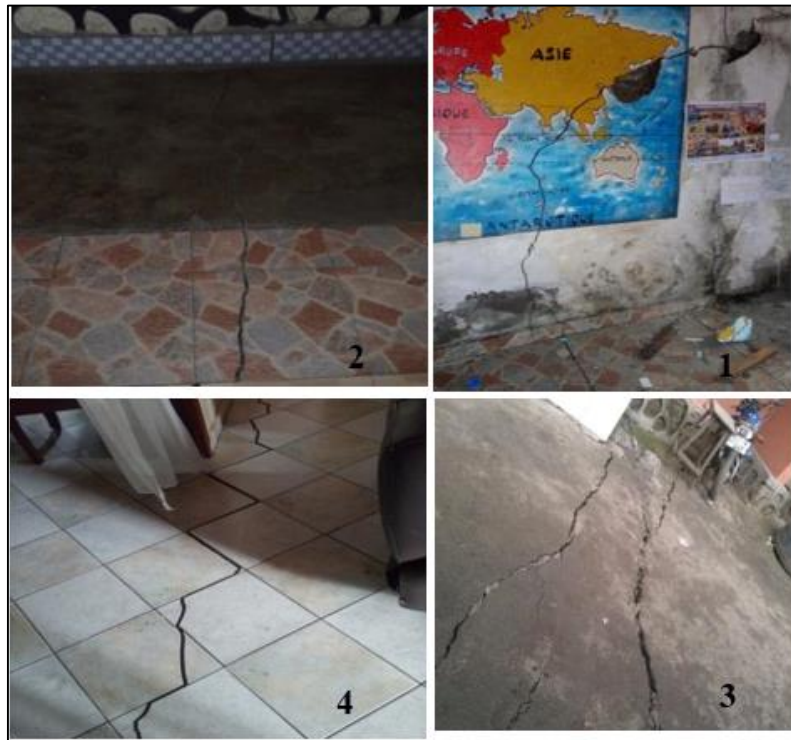
During the big earthquakes recorded in the region after the eruption of Nyiragongo, we recorded several houses, schools, churches that were affected by these felt earthquakes. The population of this area still ignored the danger and allowed

themselves to build on old vents, fractures and other volcanic tunnels.

**Fig 7:** (3, 4) House cracks and (1, 2) Schools
